St Margaret's Old Church, Hopton on Sea

An Historic Building Survey by Andy Phelps BA

September 2011

Location: Coast road, Hopton on Sea, South Norfolk, National Grid Reference: TM 5300 9996, Designation: Grade II listed LB No. 227769, Historic Environment Record No: 10760, Status: Disused and Ruined

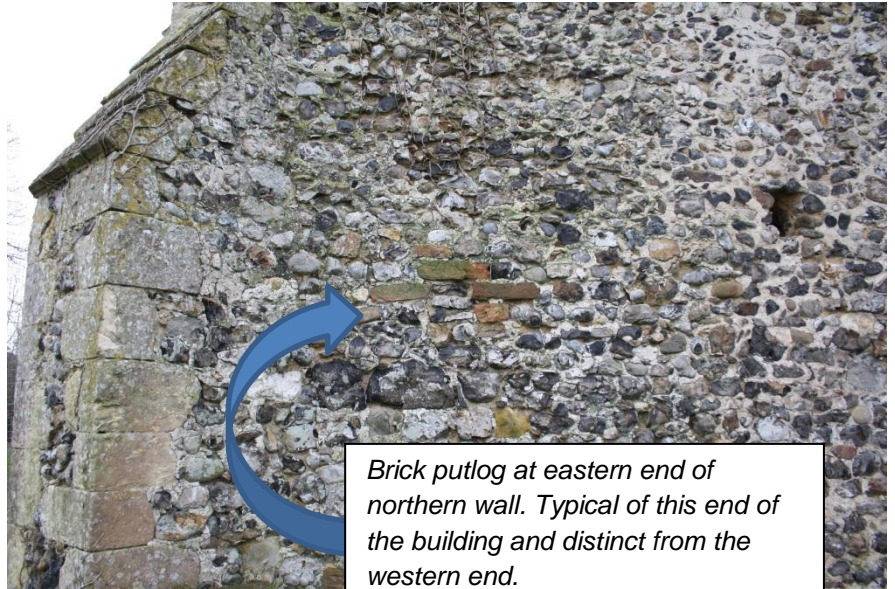
Brick putlog at eastern end of northern wall. Typical of this end of the building and distinct from the western end.

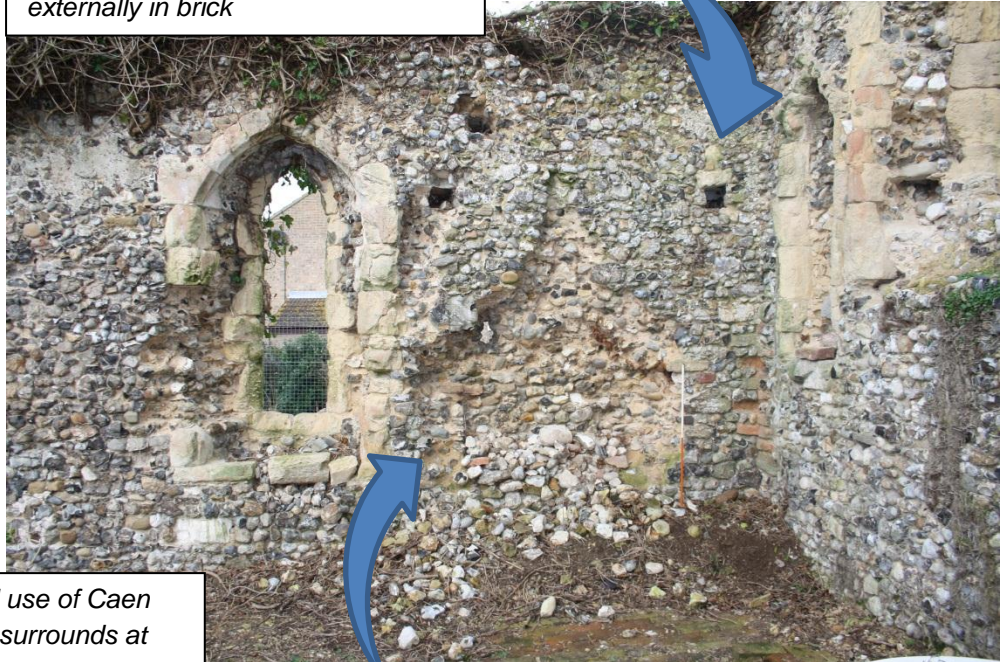
*Putlogs internally framed in stone,
externally in brick*

*Note also the internal use of Caen
stone for the window surrounds at
this end of the wall*

*'Un-enclosed' aumbry at eastern end
of northern wall.*

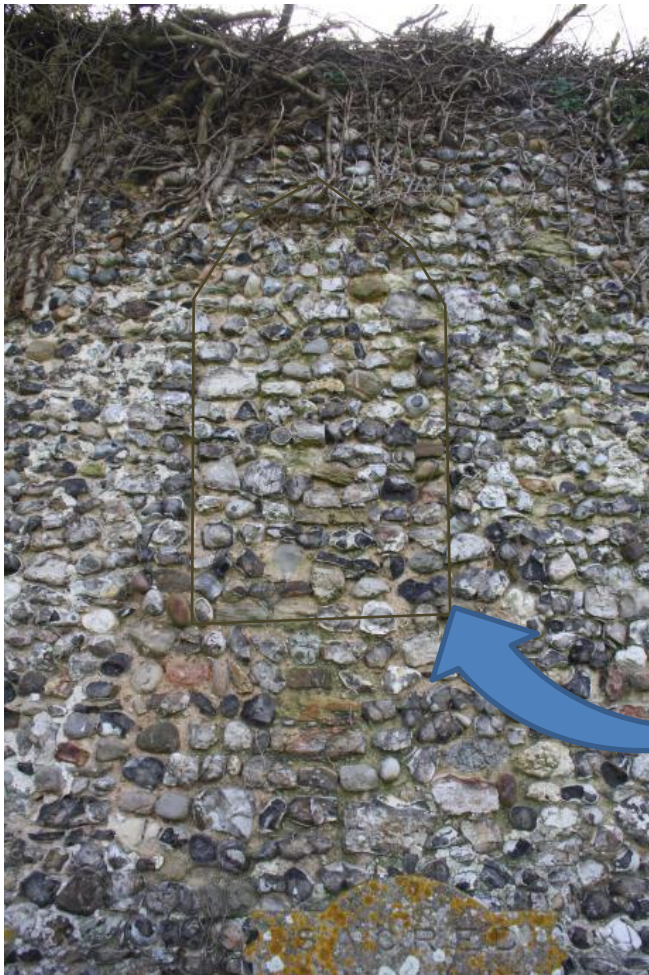
*In-filled window at east end of north
wall. This external view has been
highlighted in outline but internally
the plastered splays can just be
seen where later flint work has been
lost*

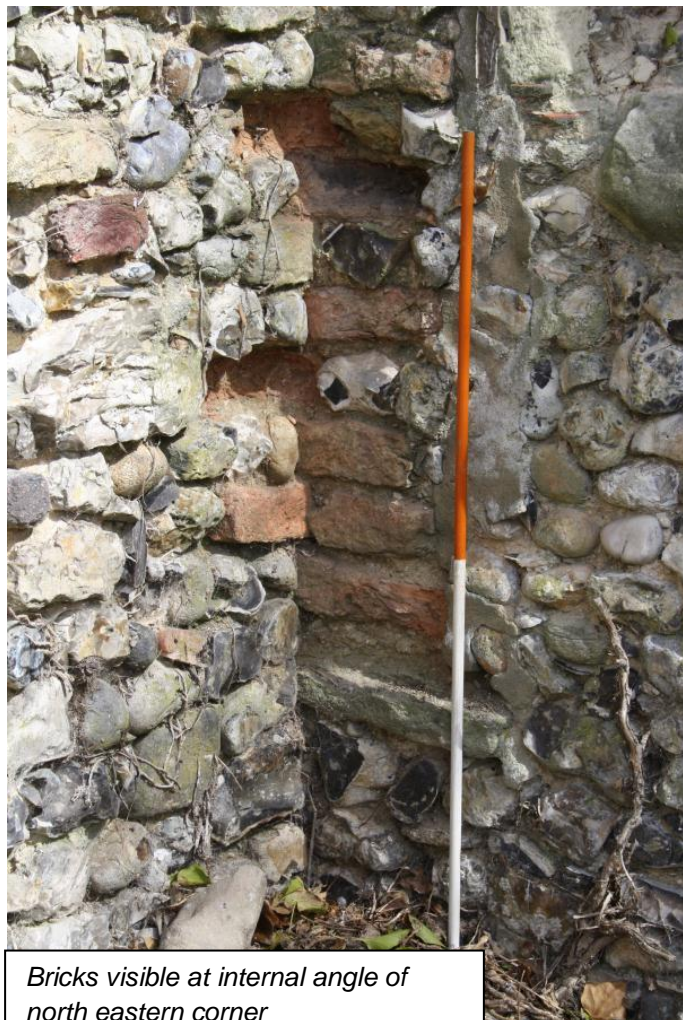
Bricks visible at internal angle of north eastern corner

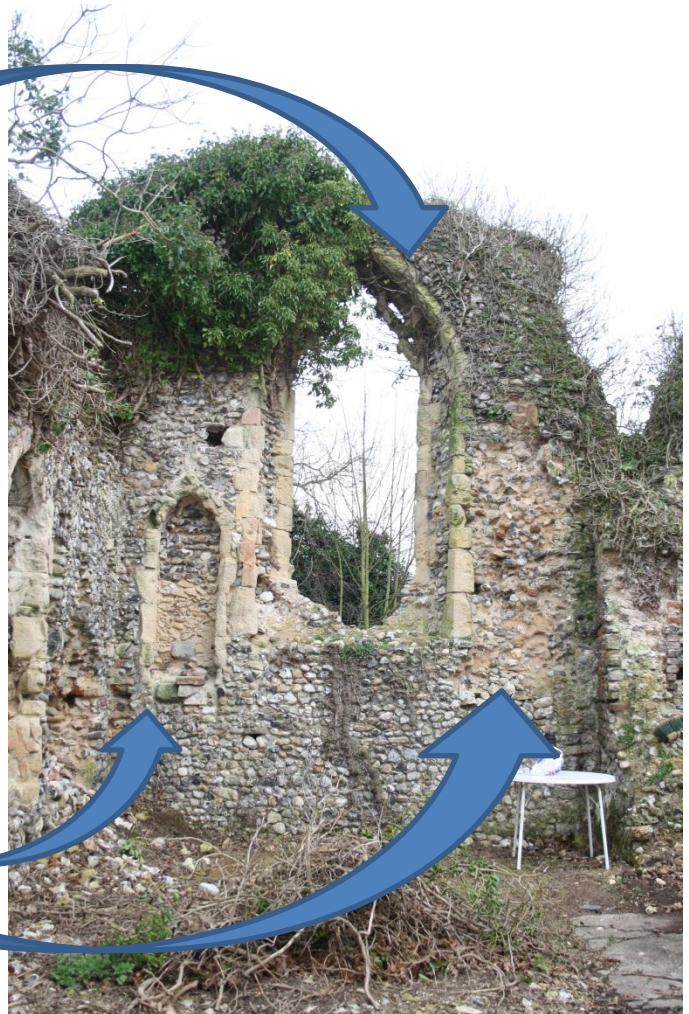
East wall of chancel with traces of reticulated tracery surviving at the head of the central window

Niches present to the left and right of the central window although that to the right lacks any enclosing stonework

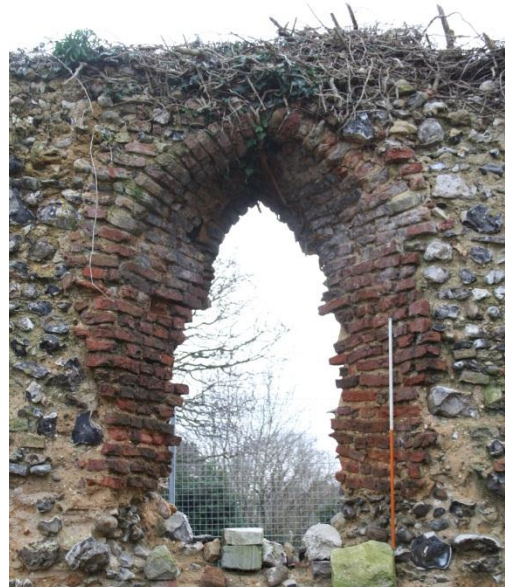
The head of this brick lancet can be seen in this southern wall window although the jambs are much eroded

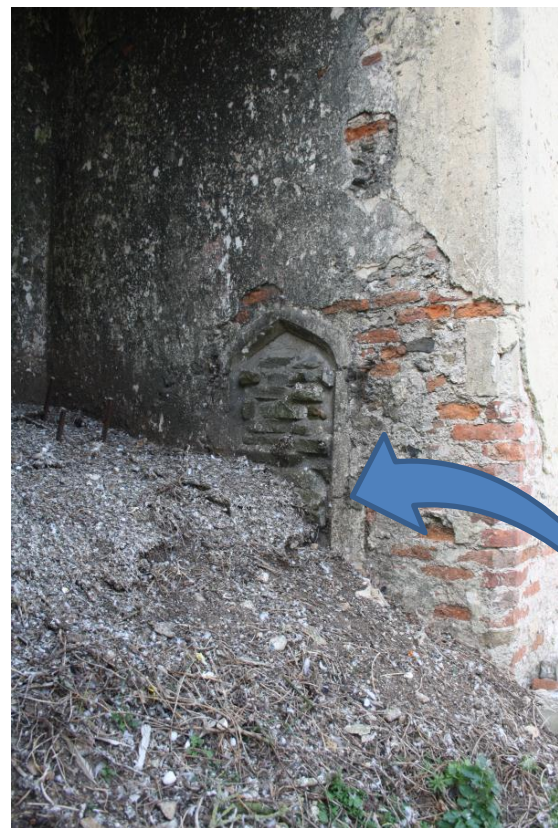
Blocked ground floor doorway at base of tower. Note the build-up of guano from pigeons nesting in the tower
