# **The Results of a Community Archaeological Project at St Margaret's Old Church, Hopton on Sea, Norfolk.**

## **Summer 2014**

Giles Emery  
July 2015

Report No: 63

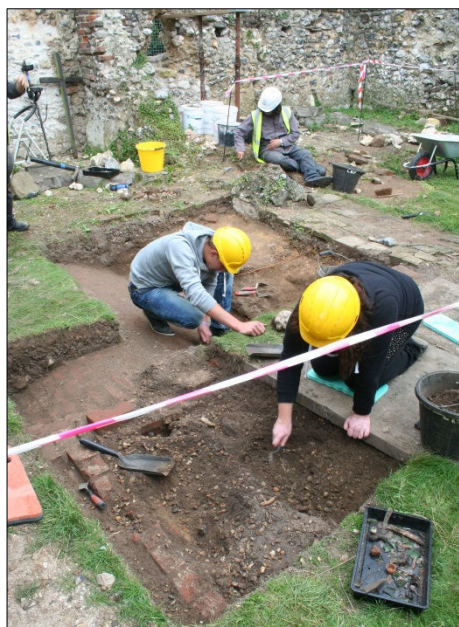
Plate 7 (left): T1 – excavation of the Sayer's family vault (looking SE)

- **Trench 1** was located primarily to relocate the Sayer's family vault, which despite being uncovered by volunteers on the Training for Life Scheme in 1980s could not now be located with any certainty. A photograph shows the group huddled around the broken open brick barrel vaulted tomb. Despite this the exact location and dimensions was difficult to determine and it was hoped that this investigation could relocate the vault's

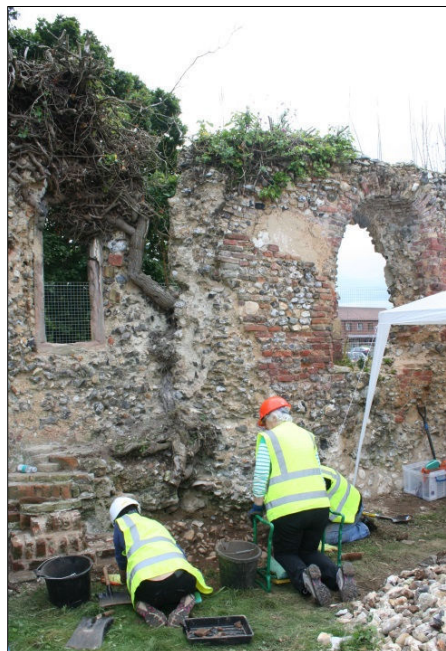
Plate 9: T4 – excavation below the joint between nave & chancel (looking south)

- **Trench 4** was located against the south wall with the objective of examining any subsurface evidence associated with a possible construction joint, most notable along the south wall, which could indicate an extension to the church. Currently no conclusive evidence exists that this is anything other than a single build, although the flints used to the east were noted by Phelps (2011) to be generally larger in size. A drawing of this elevation from the early 19th century does indicate what might be a break in construction at the same point (Isaac Johnson, 1818). If real, this could indicate the extension to the church marked by the addition of the chancel, or possibly a later expansion of the entire structure.

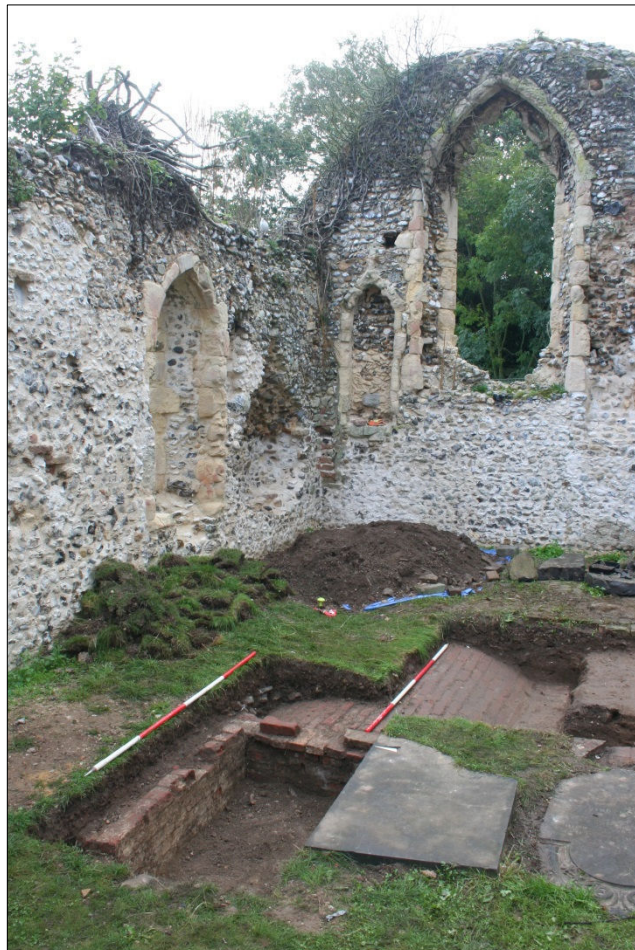
Plate 10: T1 - Post-investigation of the Sayer's Family vault (looking E) [2x2m scales]

The brick steps (121) to the 18<sup>th</sup> century Sayers family vault were rediscovered below the topsoil and partly uncovered below the 1981 backfill. Adjacent to the location of the steps was a broken heavy marker stone with a late 19<sup>th</sup> to early 20<sup>th</sup> century style of lettering which read simply 'THE GRAVE OF THE SAYERS FAMILY' and may well have been a former closing stone moved in 1981 to gain access to the vault. The side walls to the stepped entrance (123) were painted with several coats of whitewash, perhaps coinciding with the various episodes of interment. The brick barrel vault (122) had suffered some minor damage when the brick blocked opening had been enthusiastically removed in 1981, although the entrance had been neatly resealed using modern cement mortar. From the dimensions of the exposed elements of the vault, its full width and estimated length were able to be calculated, which show the vault to be c. 2.6m wide by c. 4.6m long and therefore occupying the majority of the Chancel Chapel area. Aside from the entrance, the remainder of the barrel vaulting appeared to be well constructed and intact.

The 18<sup>th</sup> century brick burial vault of the Sayers' family was successfully relocated and uncovered in the north-east corner of the church, with the full dimensions of the brick barrel vault able to be estimated from the results. The 1981 uncovering of the entrance steps and enthusiastic opening of the tomb appears to have done minimal damage to the monument, with the entrance having been neatly resealed.

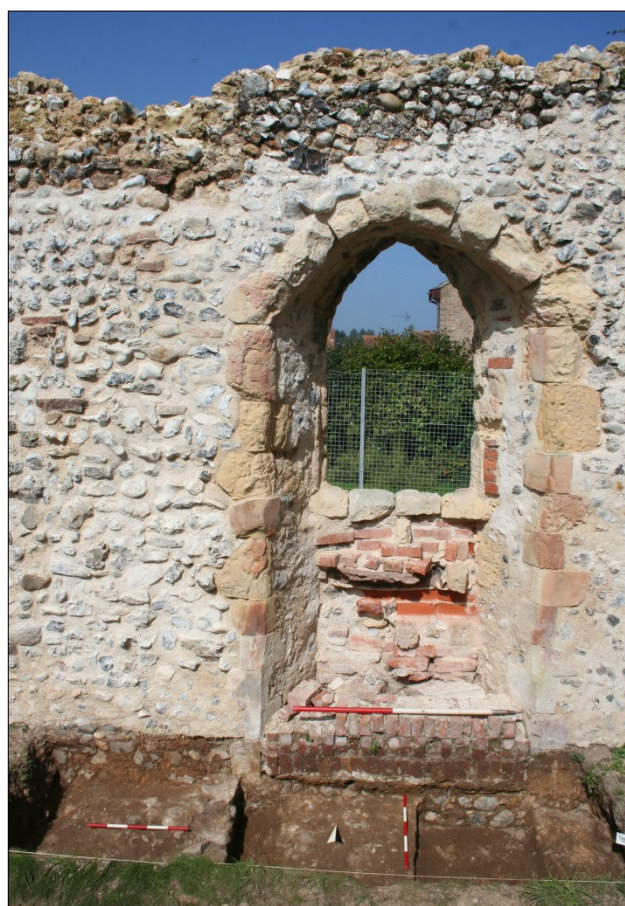
Plate 11: T2 - Post-investigation (looking N)  
[1x1m, 1x0.5m & 1x0.5m scales]

Below c. 150mm of thin modern soils, which include a gravel rich soil (108) above a sandy-loam (109) was a very shallow rubble rich pit ([140]) which mimicked the width of the window opening above, this may indicate that its purpose was to rob out any original threshold stone. The pit contained large quantities of flint building waste (up to 250mm in size) and crushed yellowish sandy-mortar debris and occasional amorphous scraps of limestone, brick and tile (113). Two larger pieces of stone were collected and have been identified as Caen stone, one of which may be a jamb fragment. Seven fragments of ceramic building material were collected for identification, which include pieces of medieval roof and floor tiles, late medieval Flemish floor tile and both medieval and late post-medieval brick of 19<sup>th</sup> century type.

This disturbance appeared to truncate a possible trace of mortar flooring, which could also have served as a bed for a tiled surface (142). The south-east corner of the trench caught part of a sub-circular pit or scaffold-posthole ([135]) which contained a mottled mix of sandy-silt mixed with fragments of late medieval and post-medieval ceramic building material (136).

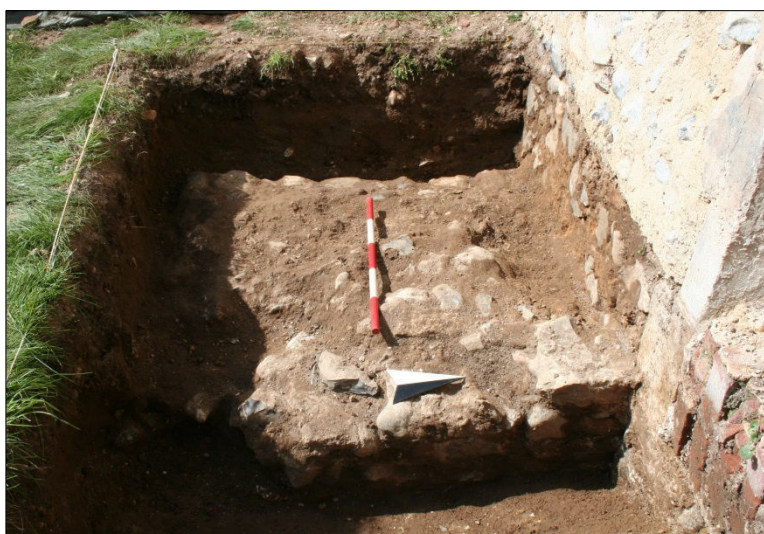
Plate 12: T2 – Masonry footings 115 (looking W)  
[1x0.5m scales]

The western part of the trench exposed the edge of an unexpected masonry build of flint and mortar on a north-south alignment and the trench was quickly expanded to investigate further. The additional work uncovered the full width of these masonry footings (115). They measured 0.9m in width and were finely constructed of moderately well-sorted flints bonded in regular courses with a hard white sandy-mortar. The depth of these footings remains unknown, although exceeds 0.3m. The fabric was robbed to just below the expected level

A below ground construction joint between the N-S wall footing (115) and the western stone work of the blocked doorway instigated a review of the flint fabric on the north facing elevation on the external side of the wall. A fairly subtle but convincing change in fabric can be discerned which matches the vertical projection of the joint. The nave wall is of generally larger flints used in more regular and even courses, as noted by Phelps who also commented on a differentiation between the relative heights and forms of the putlogs in both walls as well as the windows (3, 2011). This combined evidence shows that the north aisle and Chancel Chapel were indeed constructed in two distinct phases, the Chancel Chapel representing an extension to the 'new' north nave.

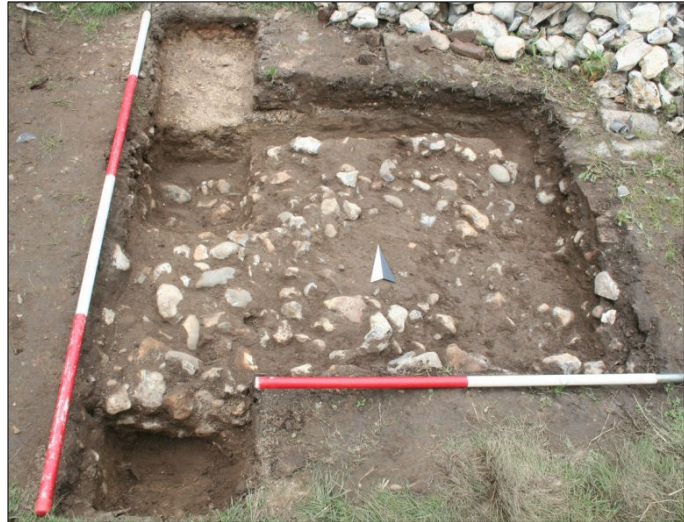
Plate 13: T3 – Earth and stone packed footings 128 (looking N) [1x2m & 1x1m scales]

A thin layer of topsoil masked an ad hoc surface of broken pavement tiles which formed part of a rough path running east to west (102), below which a very stony layer of soil was uncovered (111). Buried below this, and running east-west, was a wall-foundation of c. 1m width constructed of well-packed flint cobbles set within a dense sandy-silt (128). This footing material was trench-built and comprised of well sorted flints of c. 80mm on average with some up to 150mm. The base of this earth packed stone footing was not reached but was demonstrated to exceed 0.4m in depth.

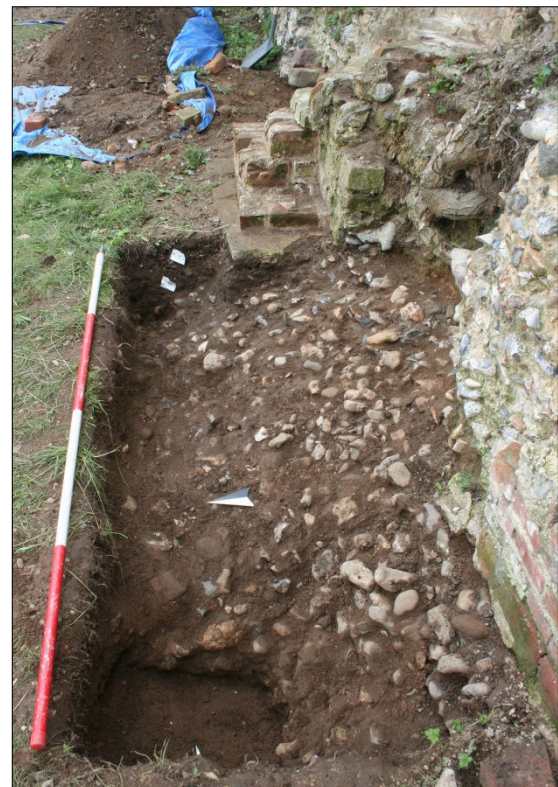
Plate 14: T4 – Earth and stone packed footings 137 (looking E) [1x2m scale]

Revealed directly below the soils was a stone and earth packed foundation of the same type as discovered by T3 (137). These footings were even more substantial and included a corner return. Most significantly this has identified the presence of a former 'end wall' which must predate the creation of the Chancel and, along with the wall footings in T3, indicates the presence of an early phase of building. This aligns well with the suspected joint in the above ground masonry between the existing Nave and what can now be proven to be the extension of the Chancel. The trench containing this footing material was dug into a clean deposit of greyish-brown sandy-silt (138) with very rare flecks of charcoal. In light of this below ground evidence, a fresh examination of the internal and external faces of the walls shows that the tree growth responsible for pushing out the walls here appears to have exploited an existing construction joint between the earlier fabric of what is now the south nave and the extension of the Chancel, as depicted in Isaacs illustration of 1818 (Plate 4).

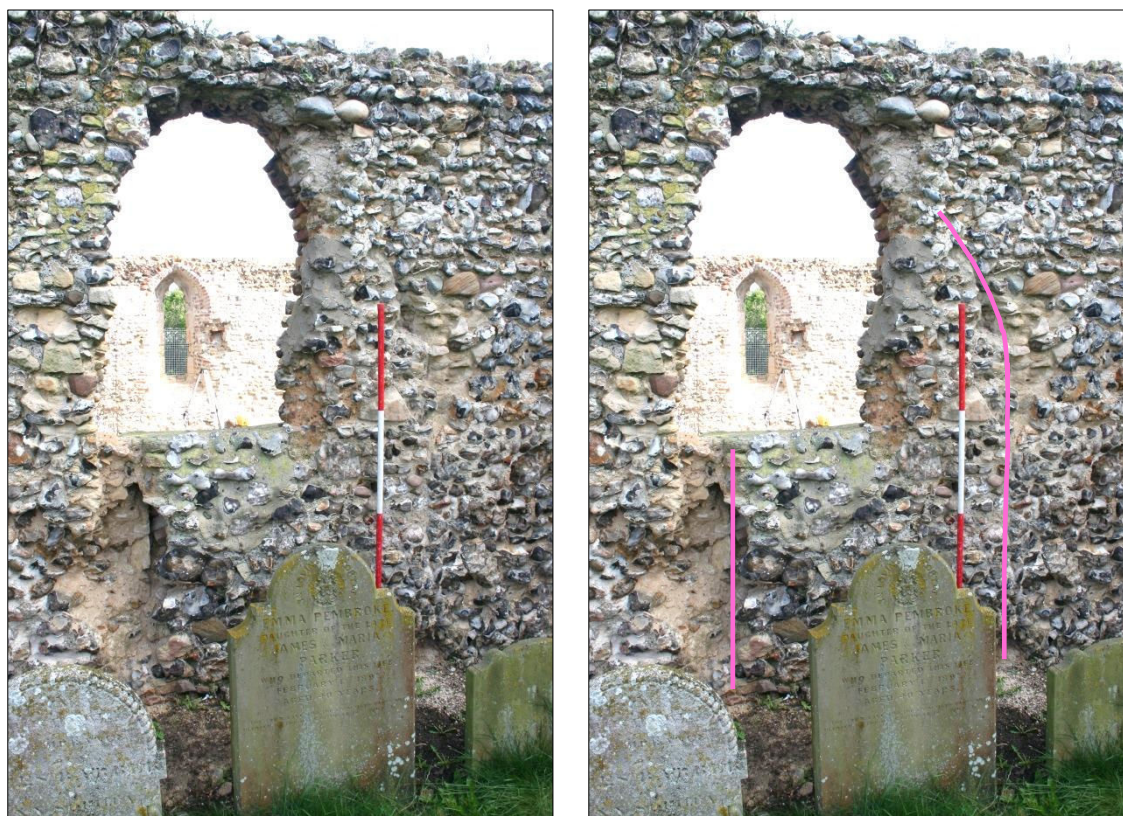
During the project, a previously unnoticed blocked doorway was identified within the southern wall pierced by a later window. The west side of the ashlar blocks forming the jambs for the doorway were exposed by recent erosion of the masking flint face work on the external face of the wall, where fine, relatively small and limestone blocks were brought to light below the sill of the later window (N7). Once identified, the eastern side of the blocked door could also be discerned by the presence of a blocking joint and traces of highly abraded Caen limestone c. 2.3m above the ground level, which mark the remains of the blocked arch for the doorway. The original portal measured c. 1.4m in width and although the form of the arch is difficult to assess it appeared to be c. 2.5m high and of a relatively simple form, such as a lancet or equilateral formed arch, which would be consistent with a pre-1300s construction date for Norfolk (Fawcett 7, 1974). This lost door must have served

Plate 15 (left): Blocked medieval doorway (looking N) [1x2m scale]

Plate 16 (right): Blocked medieval doorway defined by coloured line

the original nave and possibly also the initial single celled church. Just how early this initial stone structure was constructed still remains uncertain, although both the suggested phasing and this discovery suggest that an early medieval phase should be considered for this initial build.

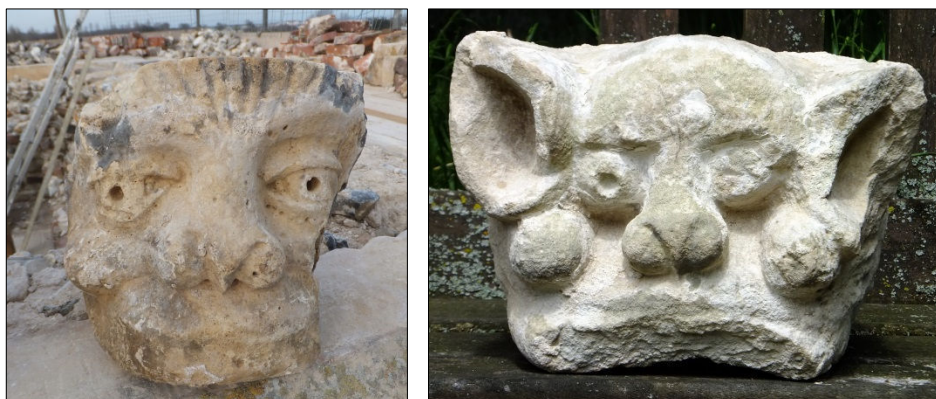
As luck would have it, during consolidation work of the church tower in 2015, two carved stone heads of between c. 200mm to 300mm in size were discovered by the conservation team on two separate occasions. They were both found as reused fragments of masonry set within the tower fabric. At present they are awaiting further analysis, but they can both be classified as grotesques of probable Romanesque style which would date them to the 11<sup>th</sup> to 12<sup>th</sup> century and although it has been suggested that they could have served as water spouts they also appear to be of the correct proportions to have served as corbels or capitals (Neil Moss *pers comm*). It is very possible that the actions of the medieval masons responsible for the construction of the tower sometime around the turn of the 14<sup>th</sup> century have preserved some of the only surviving decorative worked stone that may be attributed to the early form of the church prior to its later expansion and significant remodelling.

Plates 17 & 18: Early medieval carved stone heads recovered from the fabric of the tower by the conservation team in 2015
